## **TERMS OF REFERENCE**

### **EVALUATION OF SHELTER AND WATER AND SANITATION REHABILITATION PROJECTS (LEBANON)**

### EVALUATION OF SHELTER AND WATER AND SANITATION REHABILITATION PROJECTS

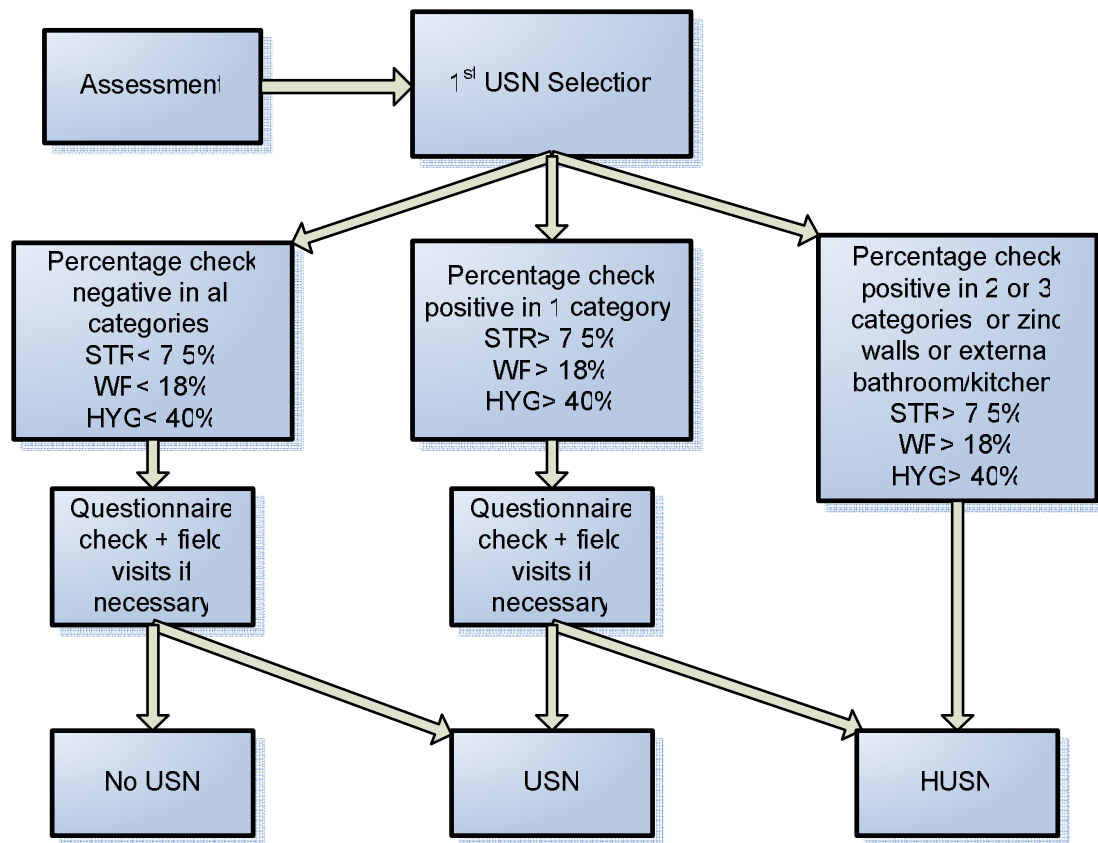
The general methodology regarding USN identification is described in the diagram below:

*Given the high number of USN, we introduced the notion of Highly Urgent Shelter Needs (HUSN). Those shelters within the USN category are the ones which suffer from a combination of major problems and ought to be considered in priority for rehabilitation.*

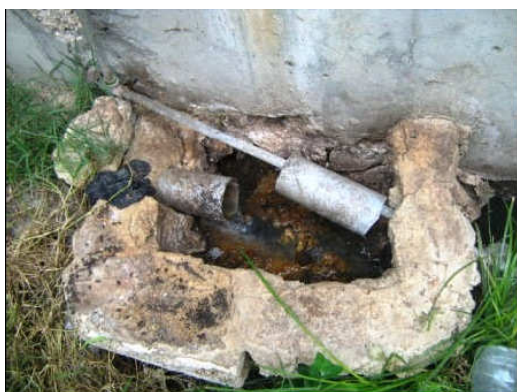
Manholes are too small and not sufficient for the large number of houses connected to them. They are quickly full of water, causing flooding in houses.

Most manholes covers have holes or cracks or are broken. This was sometimes done on purpose by local inhabitants to facilitate the evacuation of storm water. This “solution” increases dramatically the volume of water collected by the network during storms, which results in an immediate congestion.

Open-air inspection chamber

<b>Field Observation</b>	<b>Associated Risk</b>	<b>Recommendations</b>
Water network upper ground, old metal pipes	Quick and frequent damages	Creation of a new underground water network with polyethylene pipes
Some water pipes cross sewage network	High risk of contamination	Isolation of the 2 networks
Sewage pipes diameters under-dimensioned and damaged	Saturated network, flooding in houses and streets, hygiene	Change of all damaged or under-dimensioned sewage pipes
Lack of manholes at intersections and existing manholes under-dimensioned and in poor state (broken covers...)	Difficult network maintenance, numerous network saturation	Creation of new manholes, renovation or change of old and damaged ones
Common network for sewage and rain waters	Sewage network often saturated during storms	Separation of the sewage and rain network (the rain water can be evacuated upper ground)

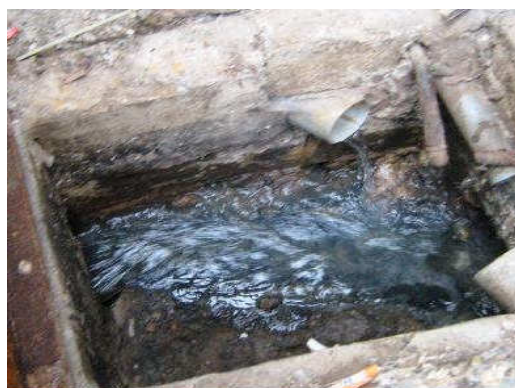
Underdimensioned manhole

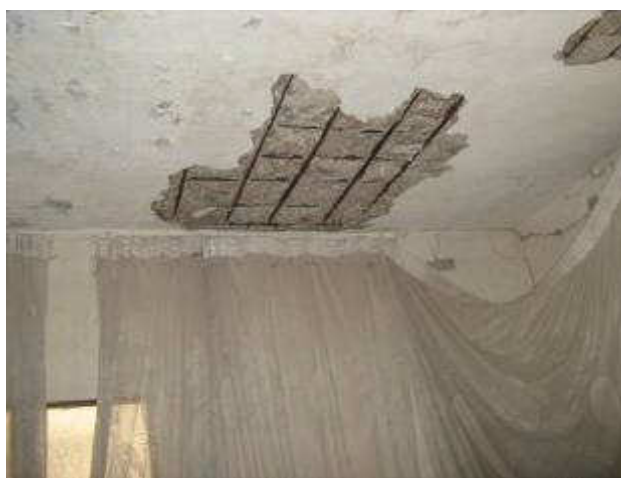
The shelters in Hamshari are single-story units in very poor conditions. Many are made of old concrete walls damaged by water infiltration and leaking zinc roofs. The sanitary situation is therefore worrying and the structure of many shelters (cracks in walls...) represents a real risk for the population.

Damaged concrete roof, rusting reinforcements

The urgent shelter needs in Hamshari are high.

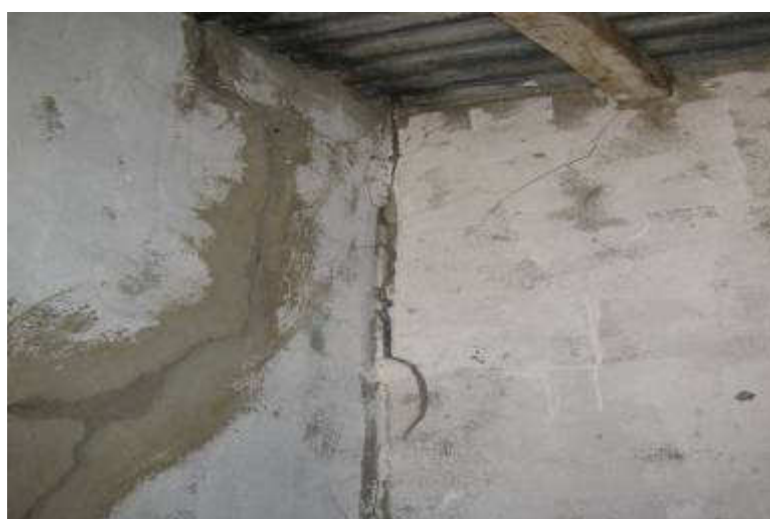
The shelters situation in Jabal el Halib is deplorable. The old concrete walls suffer from water infiltration and cracks. In some cases the hygiene inside the homes is worrying. Some houses have a zinc roof with leakages.

Crack in masonry

The shelter needs are high.

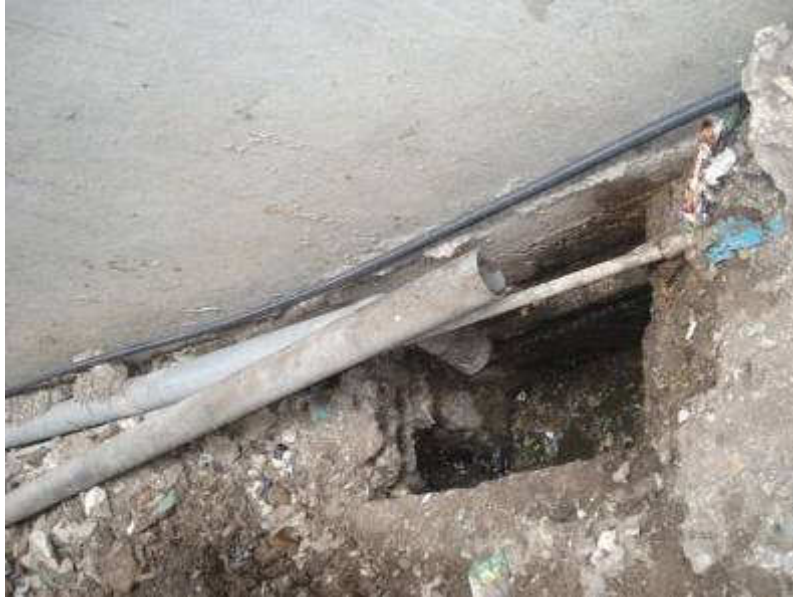
In the southern part, there is no sewage network. The shelters are either connected to storm water drainage or have badly conceived cesspits.

This situation causes a very unpleasant smell, a deplorable hygiene and increases the risk of contamination that is already important with the water pipes running upper ground.

Uncovered inspection chamber, crossed by with water supply pipes

<b>Field Observation</b>	<b>Associated Risk</b>	<b>Recommendations</b>
Water network upper ground, old metal pipes	Quick and frequent damages	Rehabilitation of the network with underground pipes
Some water pipes cross sewage facilities (cesspits...)	Contamination	Isolation of the 2 networks
No sewage network in the southern part	Saturation of cesspits, flooding in houses and streets, bad hygiene	Creation of sewage network
Existing rain water network used for sewage	Water flooding during storms	Extension of storm water network and separation of the sewage and rain networks.

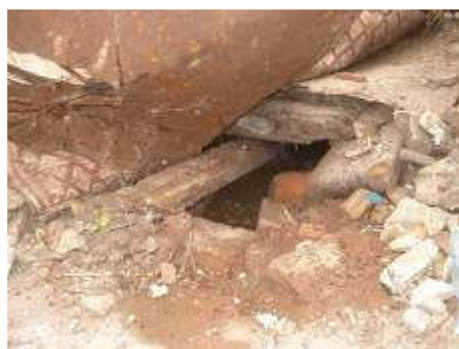
No sewage network is available. The population uses private or collective septic tanks that actually work as cesspits with no drainage system. The resulting hygiene situation is bad and the possibility of water contamination is very high.

When pits are full, people build new ones. The pits are not properly covered. A lot of small and upper ground pipes from collective cesspits are damaged.

Mouth of cesspit

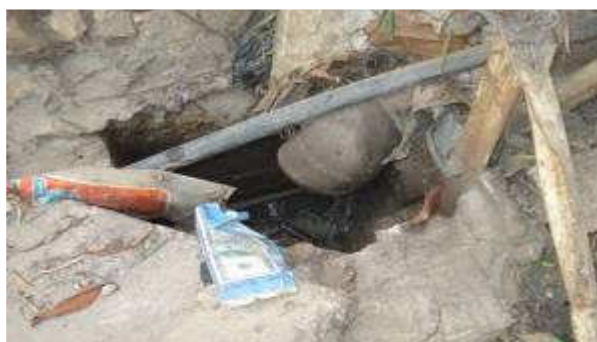
Damaged manhole crossed by water supply pipe

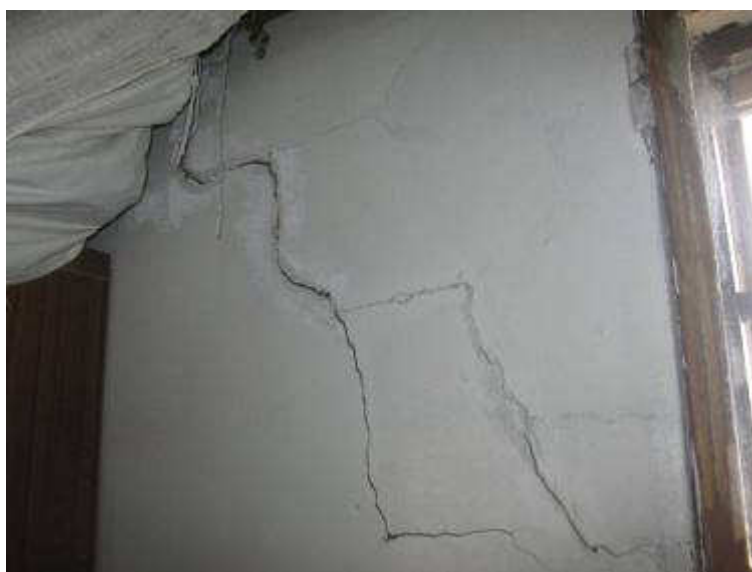
The gathering is composed of houses piled along several narrow streets. The houses face each other with only a couple of meters between them. Zinc roofs are common. Some of the refugees are people who escaped from NBC. Some minor shelter rehabilitations have already been done for these people.

Diagonal crack in masonry (symptomatic of major structural problem)

The urgent shelter needs in Mouhajjareen are moderate.

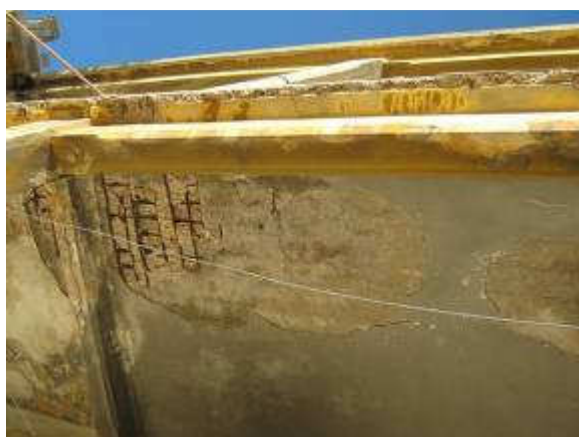
The majority of Goro's shelters are single storey units made of old concrete walls and roofs in poor state with leakages. No real rehabilitation has ever been done in the gathering since the French mandate period. The high humidity inside the houses is a recurrent issue. It has clearly a potentiality for health problems. Some houses are structurally unsafe.

Damaged concrete floor

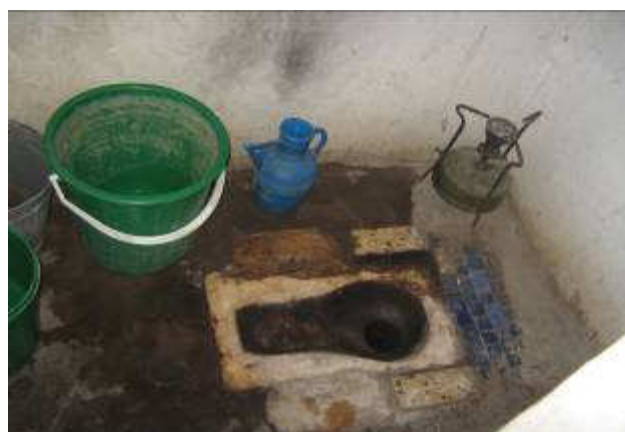
Substandard bathroom

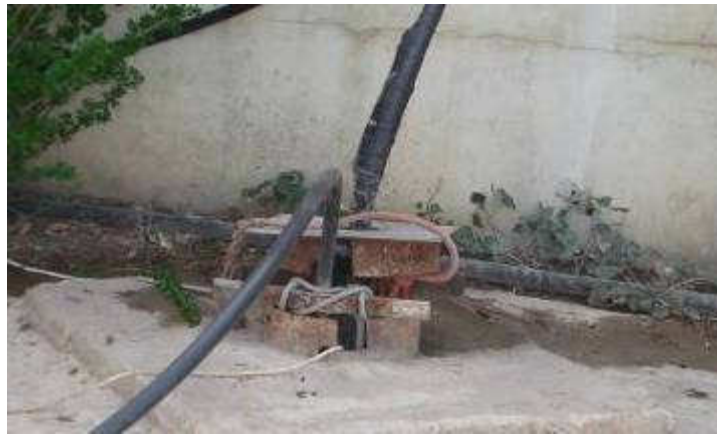
**Main source:** Private borehole located nearby Goro (see picture).

The Borehole depth is 120 meters and the water table is 40 meters deep. The general hygiene around the borehole is bad with cracks in the paving and leakages. The borehole is obviously badly protected and no chlorination is done.

Mouth of borehole

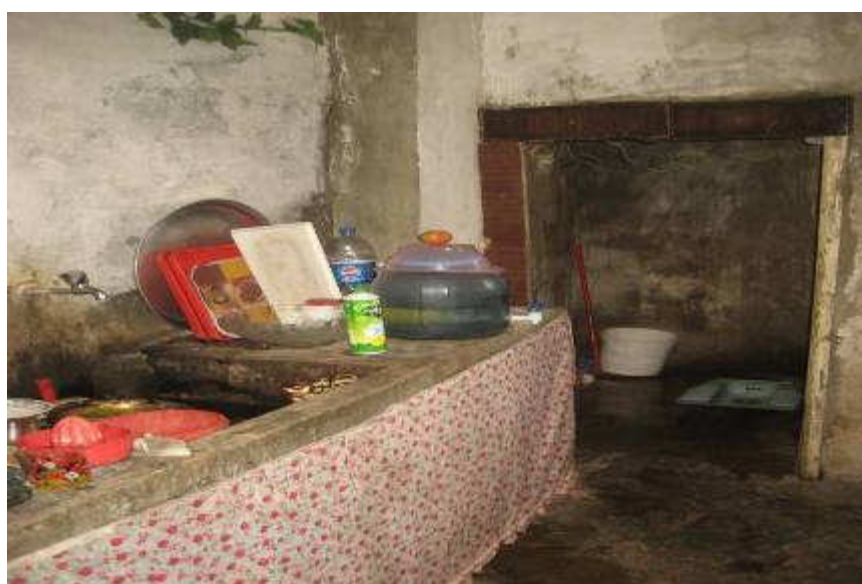
Most shelters in El Ebb are single-story units suffering from severe leakages and cracks in the concrete block walls. These problems have increased after the July war in 2006. Some houses need general repairs such as tiling, fixing of window frames and window glasses.

Kitchen and bathroom affected by high humidity and missing separation

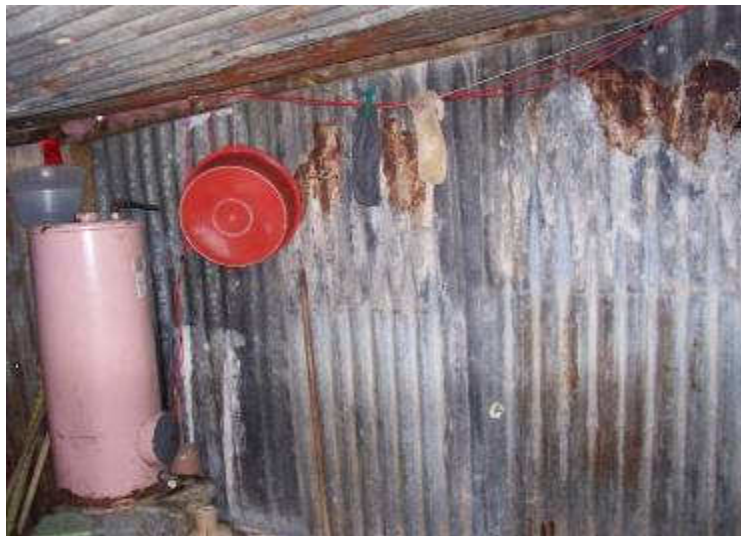
Half of the shelters in Itaniyeh are multi-story buildings while the other half single-story units. Most of the walls are made of concrete blocks but many of them suffer from serious structural problems. The 2006 war aggravated some of these problems. About a third of the roofs are made of zinc and leaking. The majority is made of concrete. Water infiltration is common.

All-zinc shelter providing insufficient protection against the weather

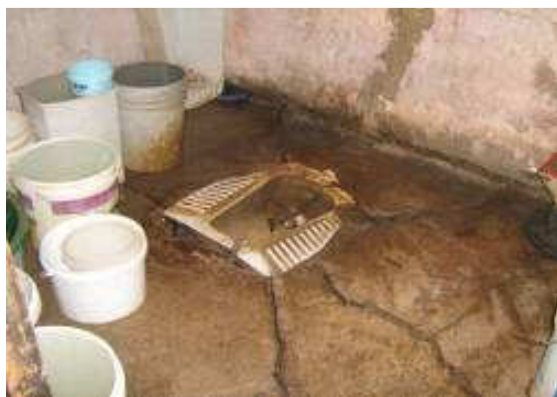
The shelters in Jal el Baher are small units built on a beach. Many of these shelters cumulate structural, hygiene and weather proofing problems. Most of the houses have zinc roofs with leakages. The walls are made of old concrete blocks infiltrated by water for many of them. There are a few zinc walls. The proximity of the sea is an aggravating factor.

Substandard bathroom

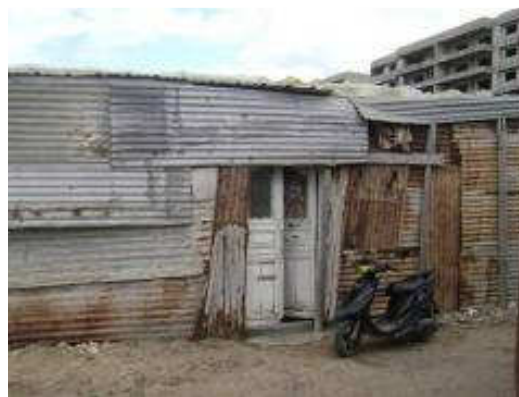
Full-zinc shelter

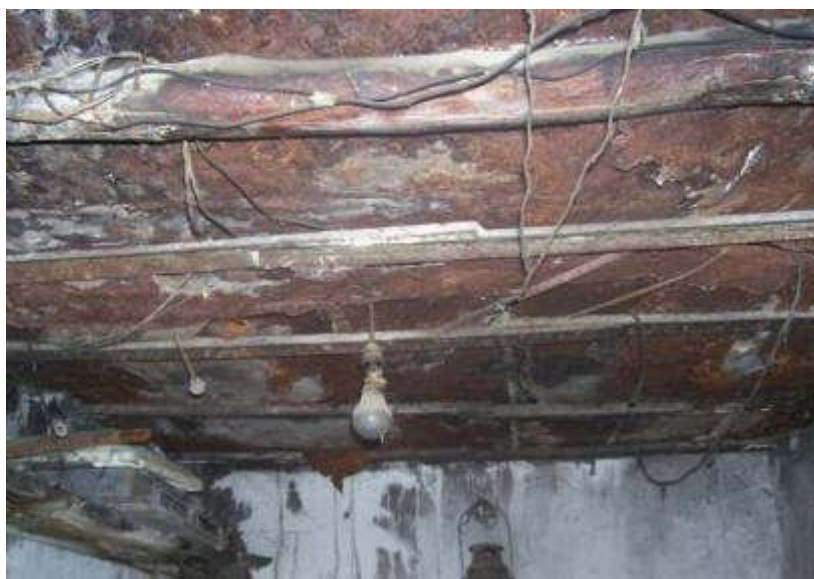
The shelters in Mashouk are multi and single-story units made of concrete block walls. There are some zinc roofs which need rehabilitation. Most of the walls suffer from structural problems which were aggravated after the 2006 war.

Outdated zinc roof

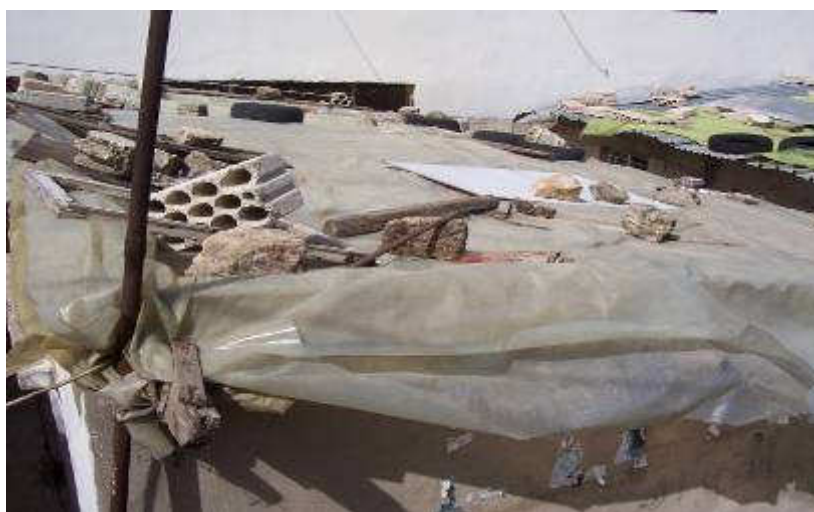
The shelters in Shabriha are mostly single-story units made of concrete block walls. Many of them have zinc roofs in bad state. A lot of shelters suffer from structural problems which aggravated after the 2006 war. Some bathrooms are external.

View of shelter zinc roof covered with plastic sheeting

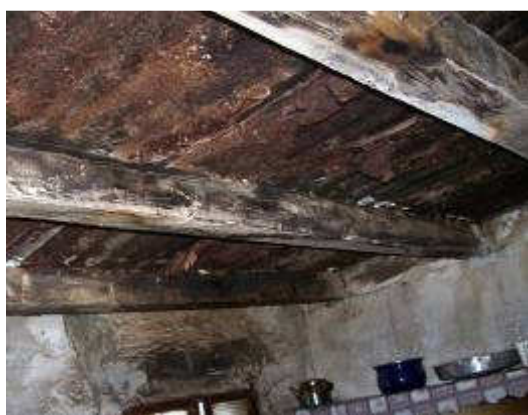
The shelters in Wasta are small single-story units made of old concrete blocks walls infiltrated by water and with serious structural problems. About half of the roofs are made of zinc and leak. Some shelters have an external bathroom. In some shelters, the sanitary situation is deplorable.

Old rusted zinc roof

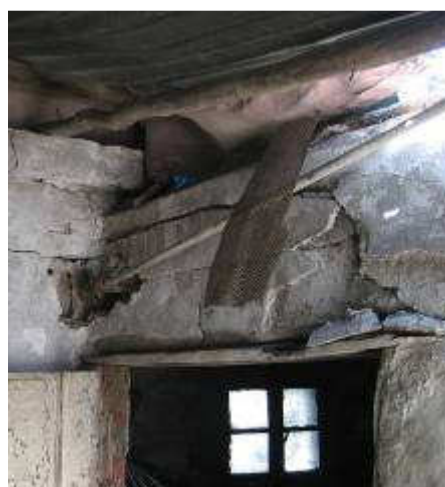
Cracked concrete lintel

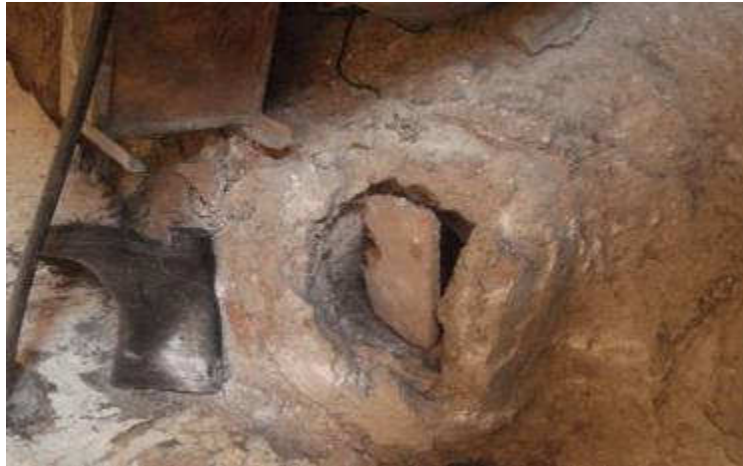
The sewage network is old and undersized. It is connected to the main Sabra line which is saturated as it is also taking in charge Shatila sewage. As Daouk is at the lowest point of the slope, it suffers from flooding during raining episodes and from regular sewage overflow. A program lead by GTZ in Shatila will decrease the pressure on Sabra main line by the construction of an independent sewage disposal.

The sanitary risk is increased by the fact that some shelters are located under ground level and can not evacuate their black and grey waters which are regularly overflowing into the houses.

Mouth of individual cesspit

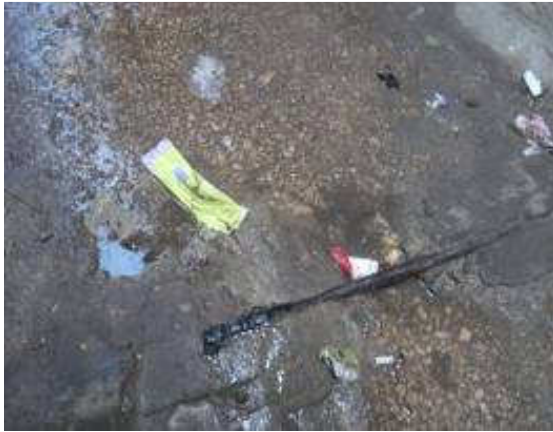
There has not been any maintenance on the network for 20 years. There are leakages along the network. The pipes are not protected and upper ground. The water tank is heavily leaking and needs urgent maintenance.

Leaking water supply pipes

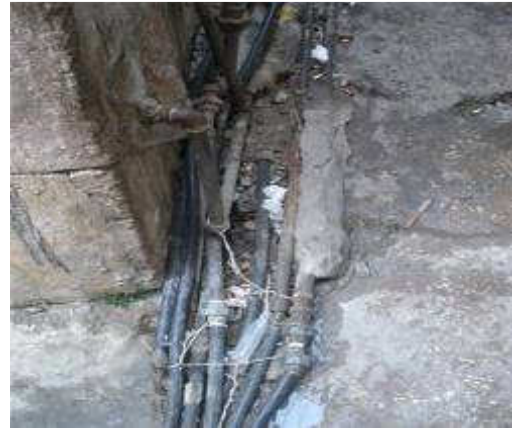
Surface water supply network
